AIRBUS WING CORROSION PROCEEDURE

Airbus A318/319/320/321 (NTM 57-29-07) March 2009

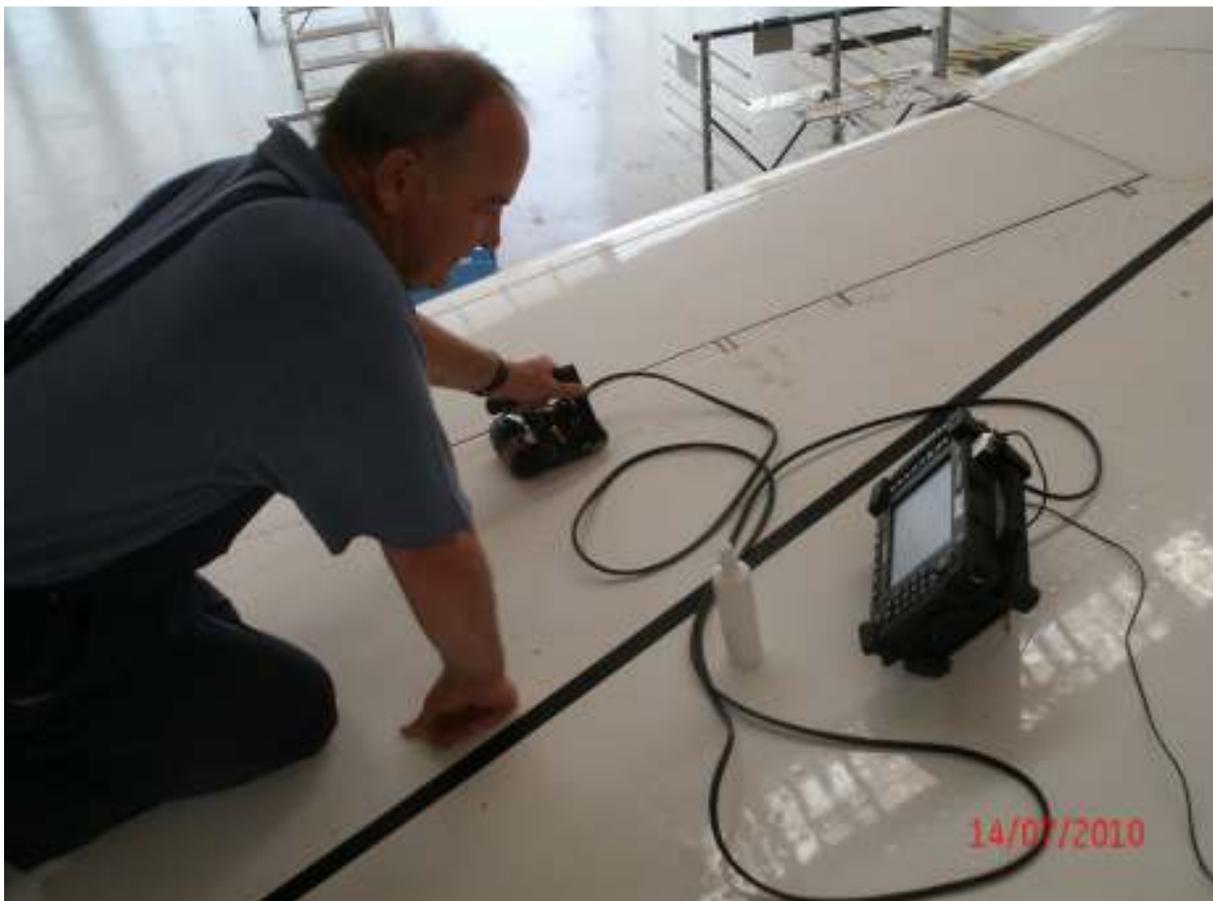
The procedure covers the inspection of 'Top Skin between the Trailing Edge and the forward fastener row of the Rear Spar and False Rear Spar', LH/RH wings. This new critical inspection for corrosion highlighted the need for fast, accurate thickness checks with the ability to detect and record defects. The solution is the Olympus Omniscan 16128 Phased Array instrument combined with the Sonatest 5MHz encoded wheel probe. Following the Airbus Omniscan set up makes this inspection accurate, reliable and repeatable. Scan information is displayed in A-C-C scans with one C-Scan based on signal amplitude whilst the second C-Scan displaying thickness and a bespoke colour pallet allows for clear visual decision making. Oceanscan offer the complete kit needed for the Inspection.
